Inspection Report
Minerals Regulatory Program
Report Date: June 23, 2005

Mine Name: Italian Tan

Quality Building Stone

Permit number: S/007/038

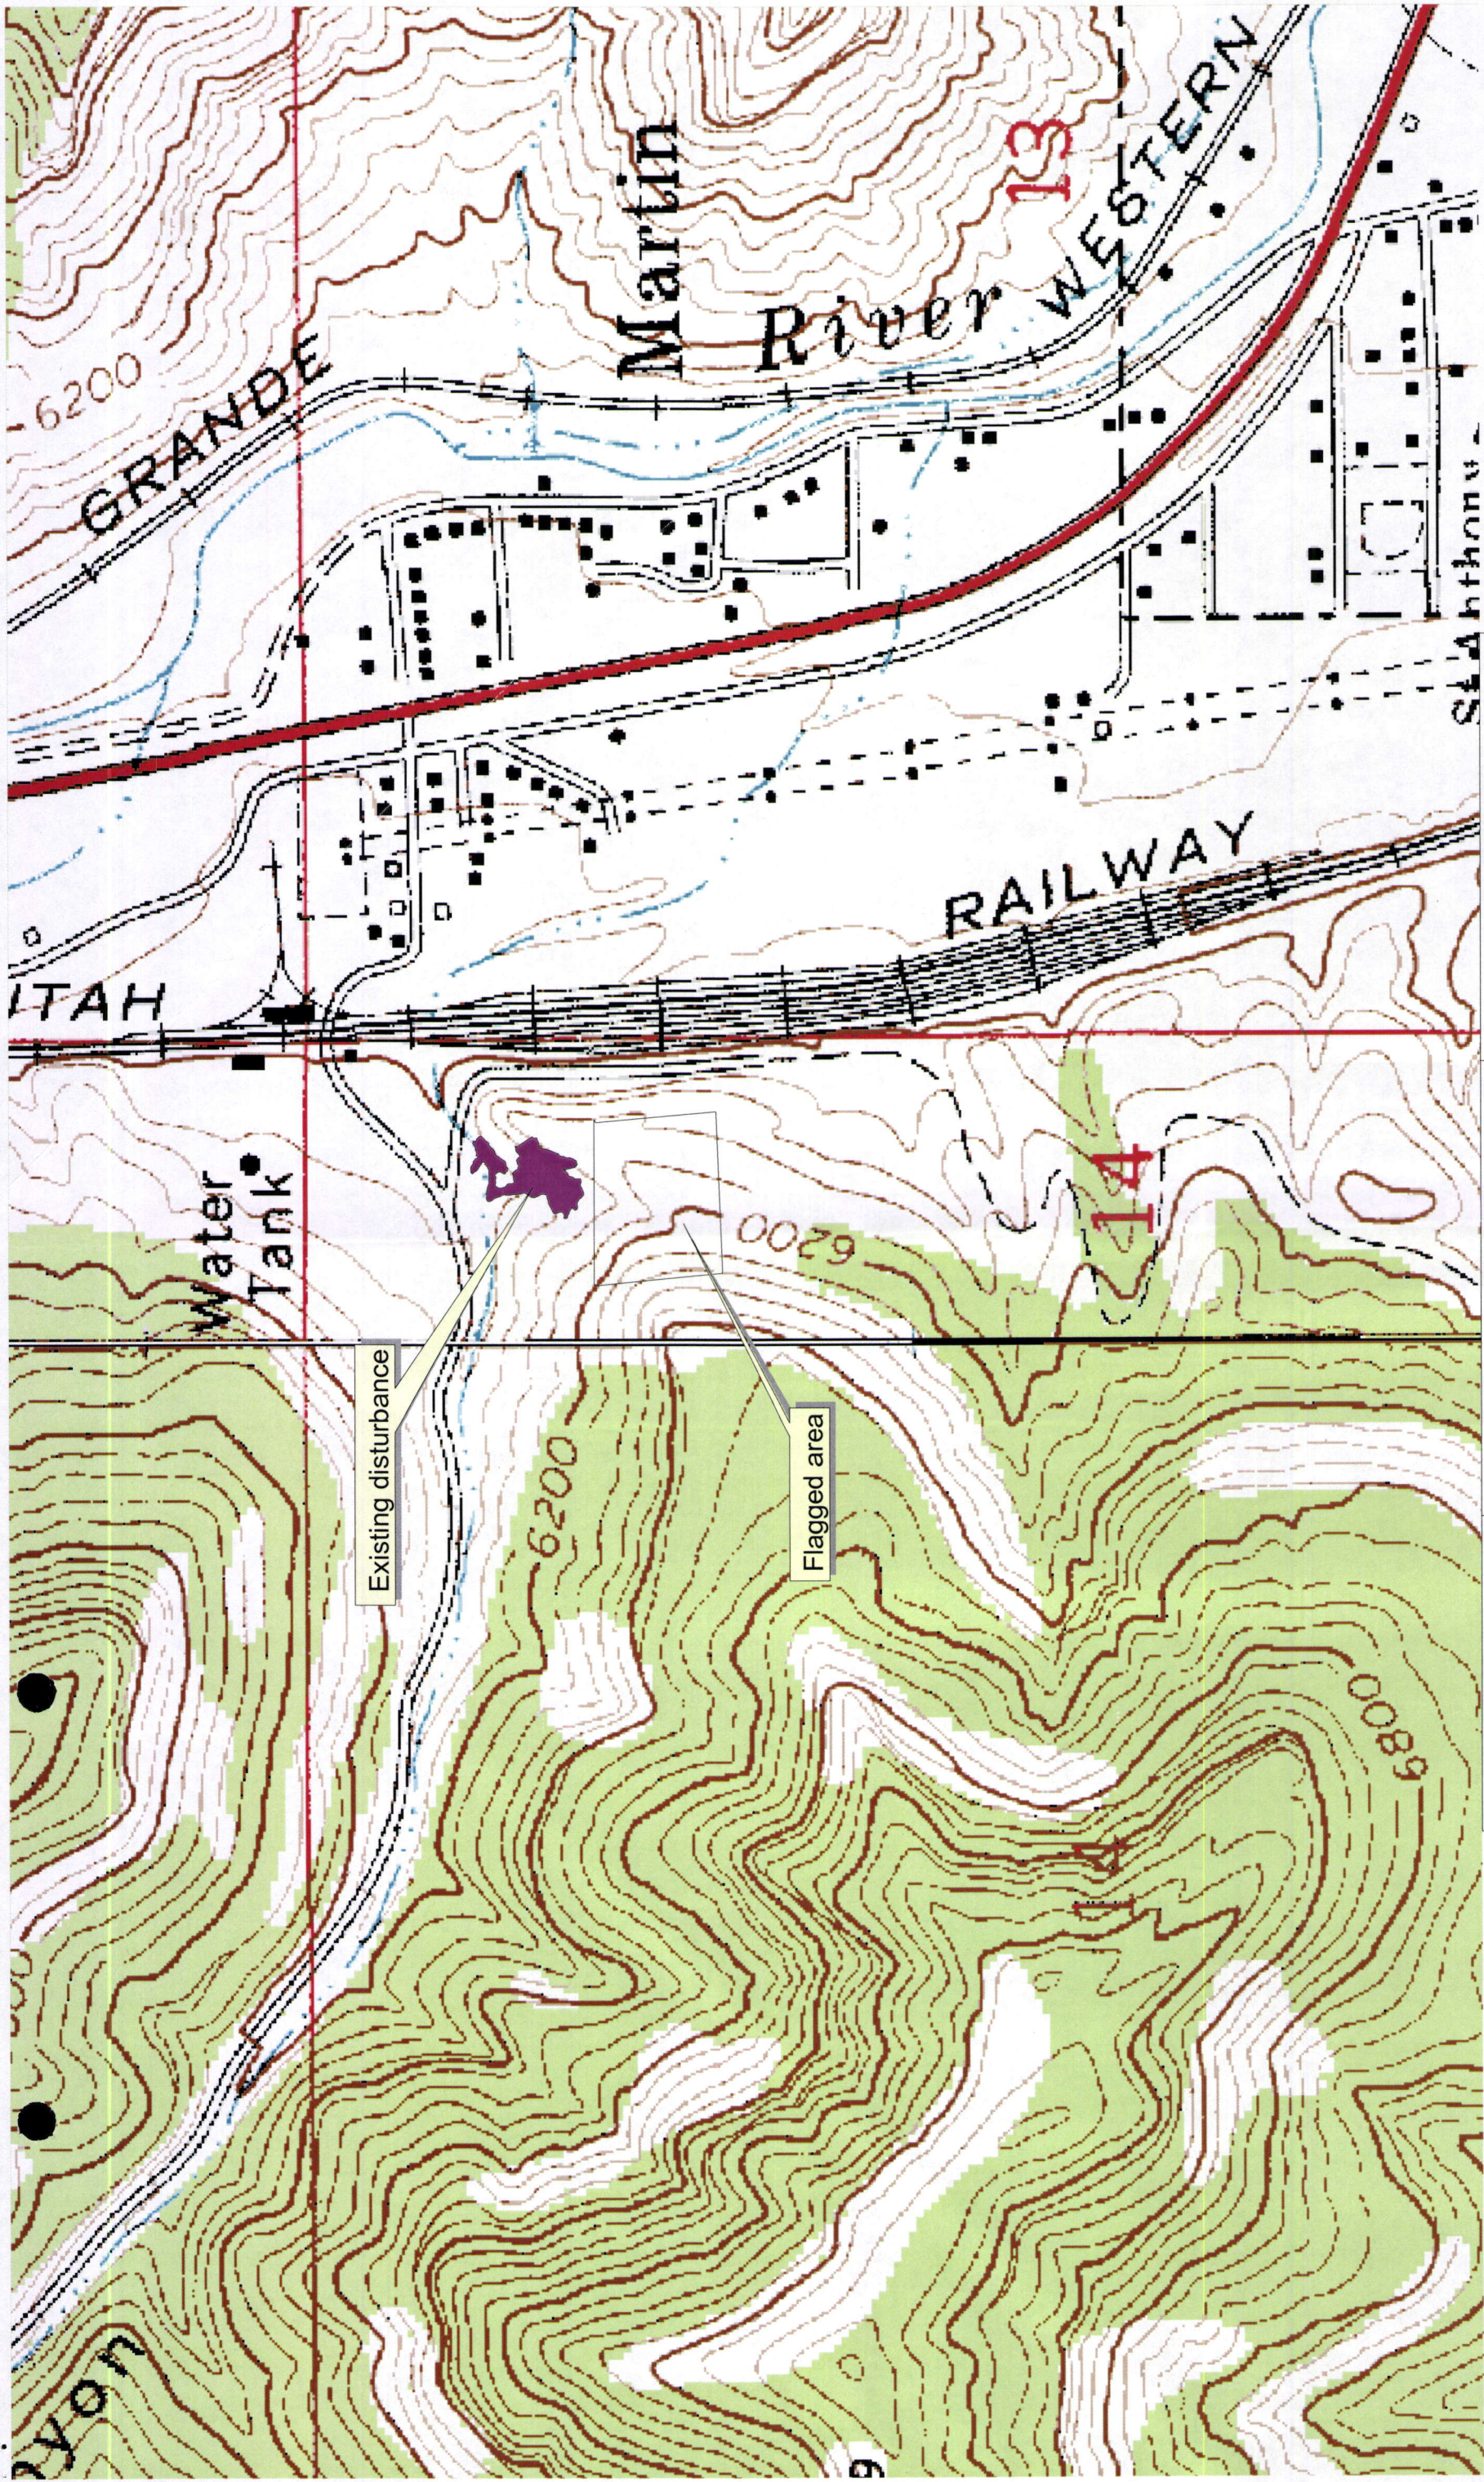
I am attaching two maps to this report. One shows the area that we flagged which is about 4.75 acres. The other shows a "new disturbance" area with the southwest boundary moved about 20 feet to the north.

Mr. Hansen should coordinate with the BLM and the Division to ensure he does not trespass on BLM property, and it may be best to hire a surveyor to determine where the boundary is.
